Manhole Inspection Summary

Manhole # S47G2_006MH

Insp Date: **3/27/09 11:26 AM**

Location Address: **Filbert-elmtree**

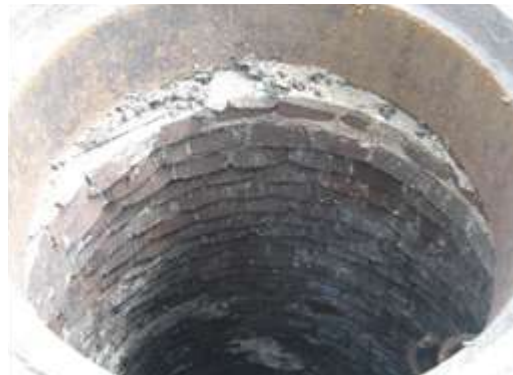
Defect 1

Frame Offset: **2** (in.) Condition: ☒ Sound ☐ Cracked ☐ Leaks

Frame offset

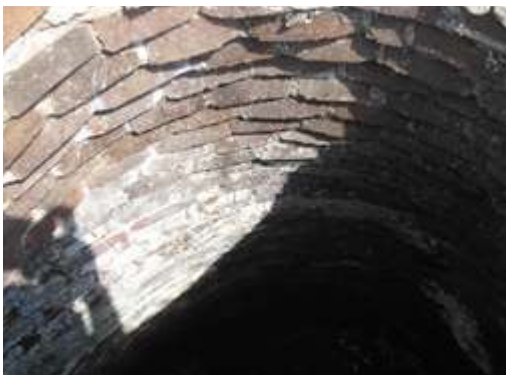
Defect 2

Infiltration: ☐ None ☐ Joint ☐ Cracks ☐ Mortar ☐ Roots ☒ Wall

Wall Infiltration

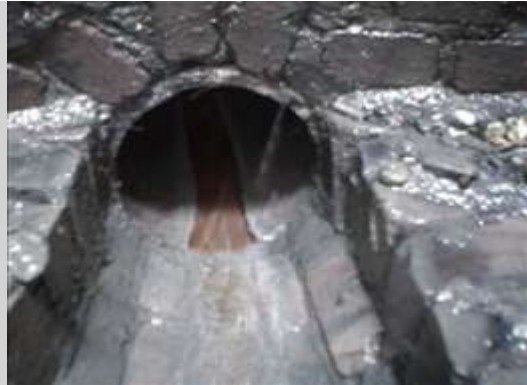
12 O'Clock Outflow

8 in. Circular Gravity Sewer
Pipe Out @ 12 O'Clock

Pipe Height: **8.4** (in.) Rod and Bar (Angled)
Pipe Material: **Clay** ☐ Pipe Lined
Invert Depth: **10.00** (ft.) Flow Characteristics: **Fast**
Deposits: ☒ None ☐ Mud ☐ Sludge ☐ **Debris** ☐ Grease
Silt Depth: (in.) Deposits Extent:
Infiltration: **None** Pipe Seal Cond: **Sound**

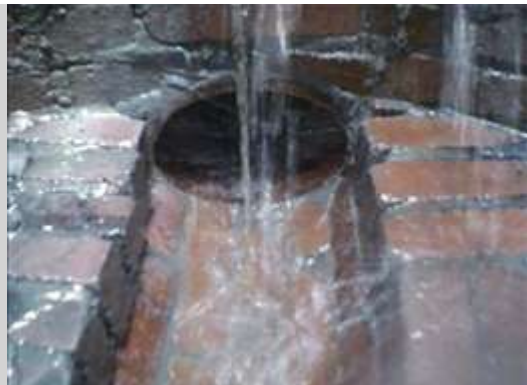
6 O'Clock Inflow

8 in. Circular Gravity Sewer
Pipe In @ 6 O'Clock

Pipe Height: **8.4** (in.) Rod and Bar (Angled)
Pipe Material: **Clay** ☐ Pipe Lined
Invert Depth: **7.14** (ft.) Flow Characteristics: **None**
Deposits: ☒ None ☐ Mud ☐ Sludge ☐ **Debris** ☐ Grease
Silt Depth: (in.) Deposits Extent:
Infiltration: **None** Pipe Seal Cond: **Sound**

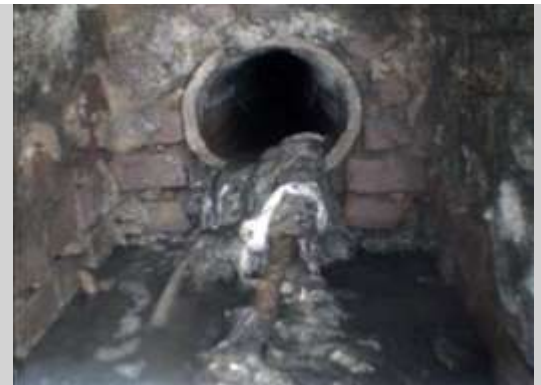
Drop In @ 6 O'Clock

Drop: **Inside** Rod and Bar
Angled: **Yes** Reading: **8.48** (ft.)
Inv Depth: **9.48** (ft.)
Drop Condition: **Open**

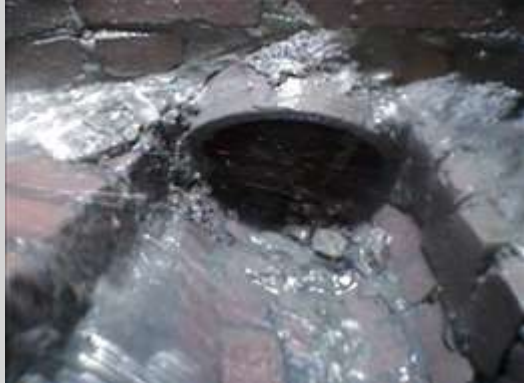
9 O'Clock Inflow

Pipe In @ 9 O'Clock

Deposits: ☐ None ☐ Mud ☐ Sludge ☒ **Debris** ☐ Grease

Silt Depth: **4** (in.) Deposits Extent: **Medium**

Infiltration: **None** Pipe Seal Cond: **Broken**

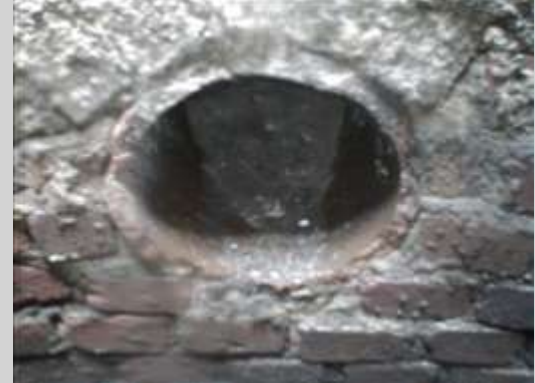
Drop In @ 9 O'Clock

Drop: Inside	Rod and Bar
Angled: Yes	Reading: 8.58 (ft.)
	Inv Depth: 9.58 (ft.)
Drop Condition: Partly Clogged
